Nine Career Fire Fighters Die in Rapid Fire Progression at Commercial Furniture Showroom South Carolina

Death in the Line of Duty...A summary of a NIOSH fire fighter fatality investigation

F2007-18 Date Released: February 11, 2009

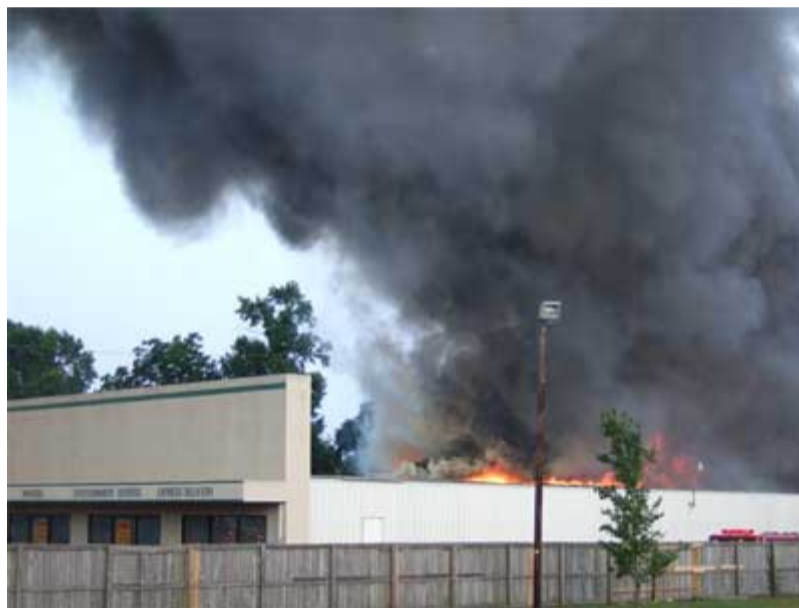
Photo1. Time approximately 1924 hours. Fire is visible over showroom roof. Smoke is dark gray in color and becoming turbulent. The flames may not have been visible from front parking lot or close to the building on the D-side.

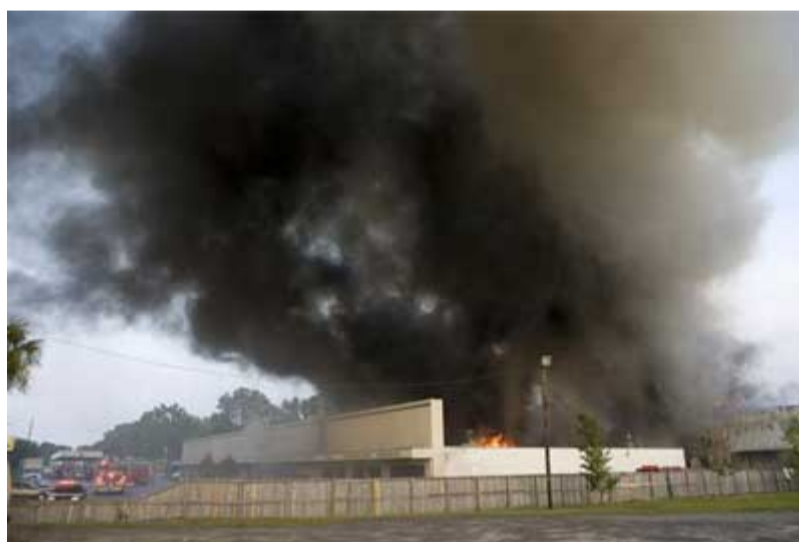
Photo 2. Time approximately 1930 hours. Note how smoke has changed to dark black color indicating it is rich with products of incomplete combustion. Note Ladder 5 and Engine 11 in front of structure as well as fire department vehicle in lower left corner. The top of Engine 10 is just visible over the fence at the lower right.

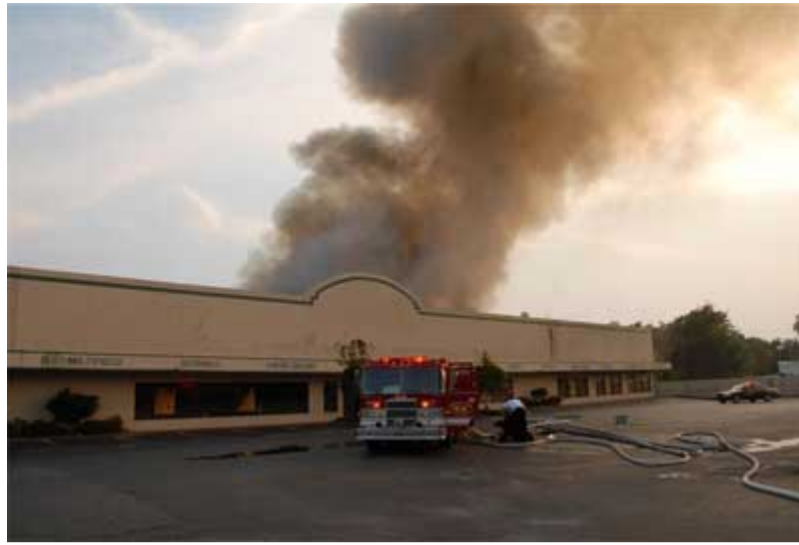
Photo 3. Time approximately 1934 hours. Note lack of any fire personnel in front of structure. At this point, the E-11, L-5, E-16, E-15, E-19, and E-6 crews are inside the showroom. Also note how the color of smoke column appears different from previous photo which may be due to the angle of the photograph and position of the sun.

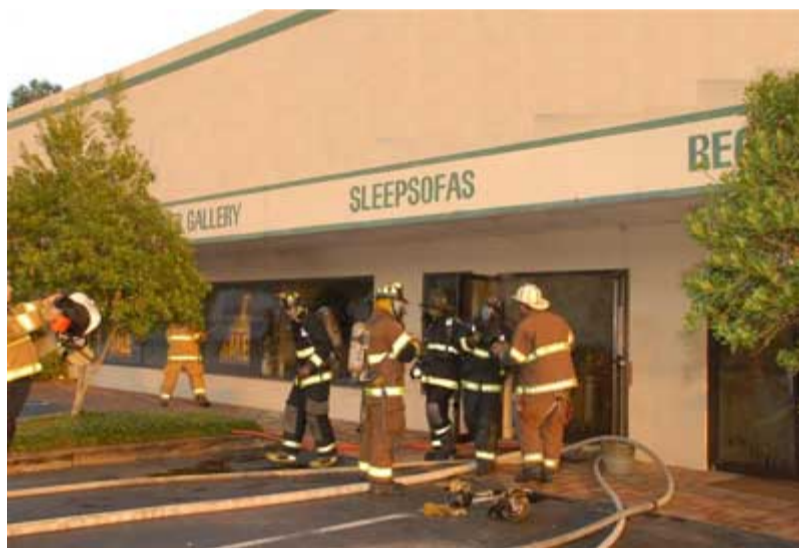
As the heat rapidly intensified, the E-6 captain began following the hoseline outside. His low air alarm started to sound and he burned his hands feeling for the hose line. His facepiece began to pull down onto his face as he exhausted his remaining air supply. He encountered the E-6 fire fighter who told the E-6 captain he had the hose line and they began moving toward the front of the building. By this time, the E-6 captain was almost completely out of air and he bolted toward the front of the building. The E-6 engineer was following the hoseline back into the showroom looking for his crew and encountered the E-6 captain who was now out of air and becoming disoriented. The engineer grabbed his captain and guided him toward the front door until they could hear the sound of Engine 11 running outside. They made their way outside followed seconds later by the E-6 fire fighter and the E-15 fire fighter # 1. The front showroom windows were just being knocked out when the E-6 crew exited the showroom ([see Photo 4](#)).

Photo 4. Last surviving members of the initial attack crews exit showroom at approximately 1935 hours.

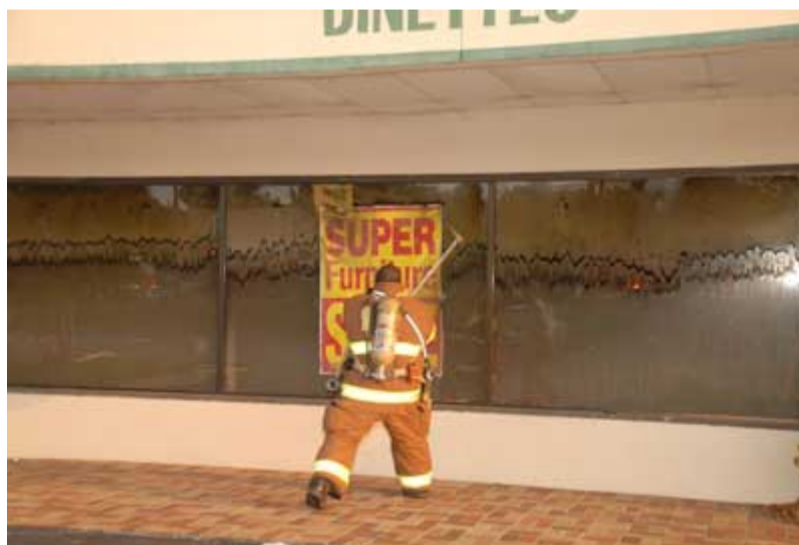
Photo 5. Time approximately 1935 hours. Mutual aid fire fighter breaking showroom front window. Photo taken just prior to mutual aid department making rescue attempt in front showroom. Note the heavy tar stains on the windows indicating the smoke inside the showroom is rich with flammable products of incomplete combustion.

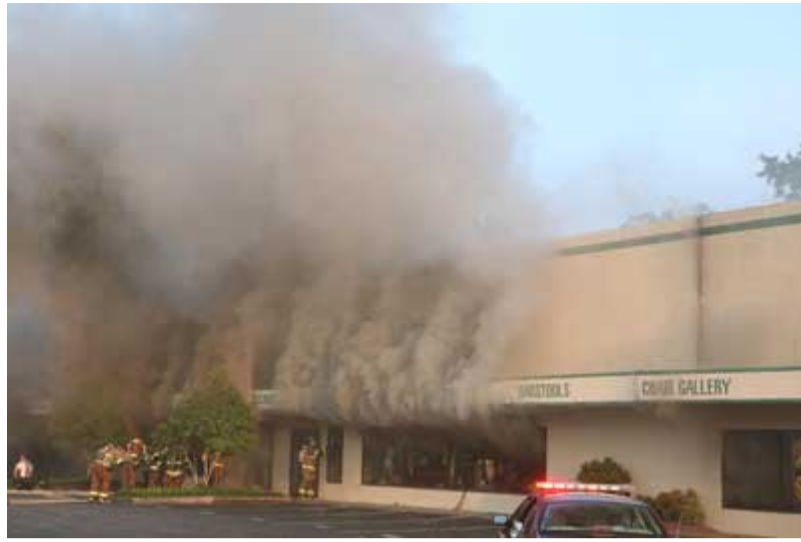
Photo 6. Time approximately 1936 hours. Note turbulent dark gray smoke rolling out of the showroom as the front windows are being knocked out. Mutual aid crew is assembling for search and rescue attempt.

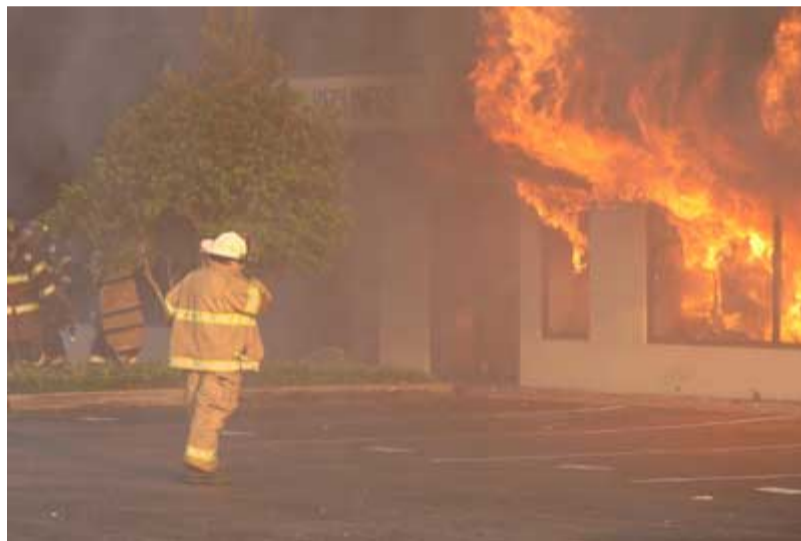
Photo 7. Time approximately 1938 hours. Photo shows conditions at front of showroom just before the interior search and rescue attempts were halted due to the interior conditions.

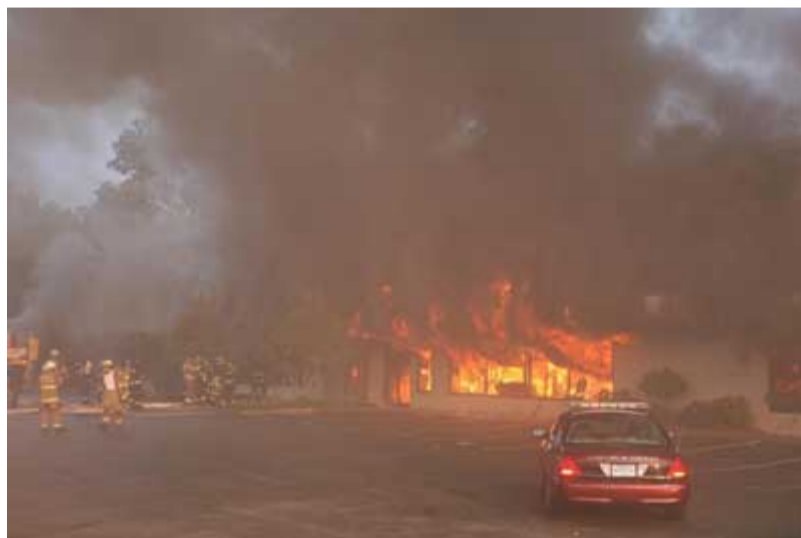
Photo 8. Time approximately 1938 hours. Photo taken less than a minute after rescue crews are forced out of the showroom by the interior conditions. Note fire rolling out the showroom windows.

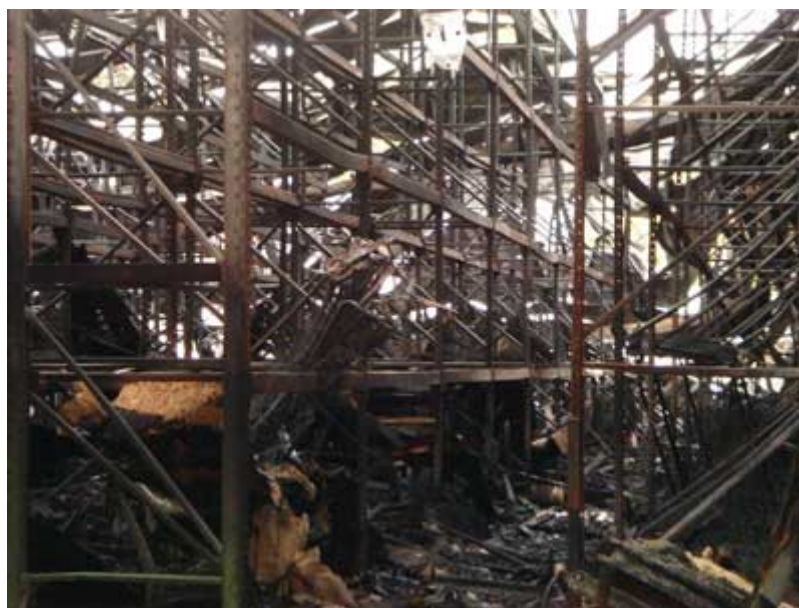
Photo 9. Storage racks in warehouse post fire. Storage racks were filled with various furniture and mattress items. Note the extent to which the storage racks filled the warehouse which gives an indication of the volume of merchandise and the fuel load inside the 15,600 square foot warehouse. The warehouse measured approximately 130 ft. by 120 ft. and was 29 ft from floor to roof.

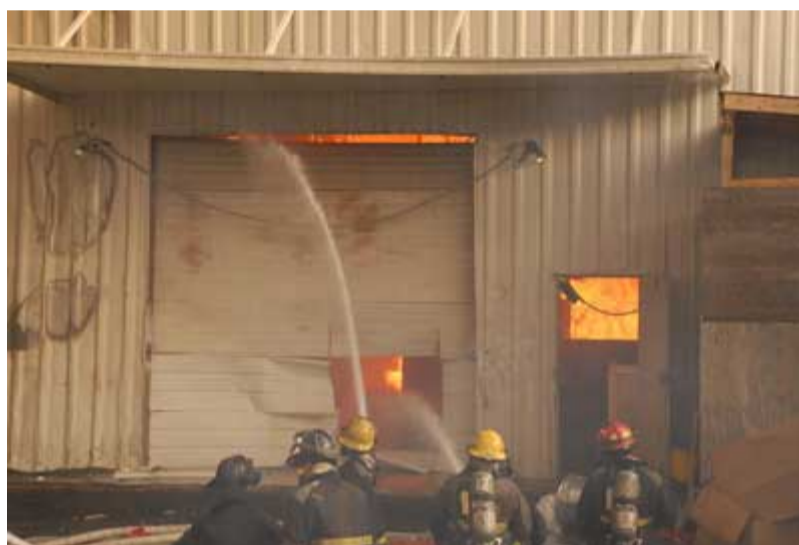
Photo 10. Time approximately 1942 hours. Engine 10 and Engine 12 crews battle fire in warehouse from outside.

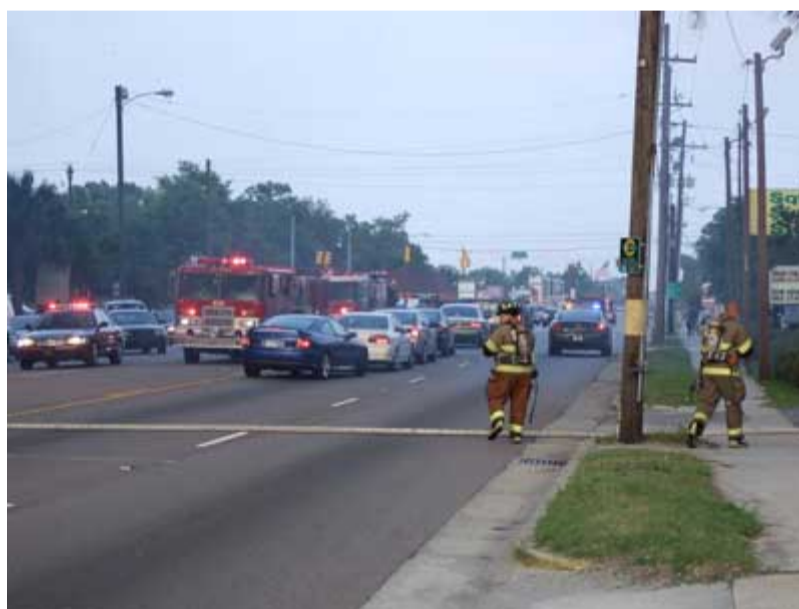
Photo 11. Time approximately 1925 hours. Note traffic on major highway in front of incident site driving over 2 ½ inch supply line. The hose line runs from Engine 12 (to left of photo) to Engine 10 (to right of photo). Photo shows mutual aid crew members arriving on scene.

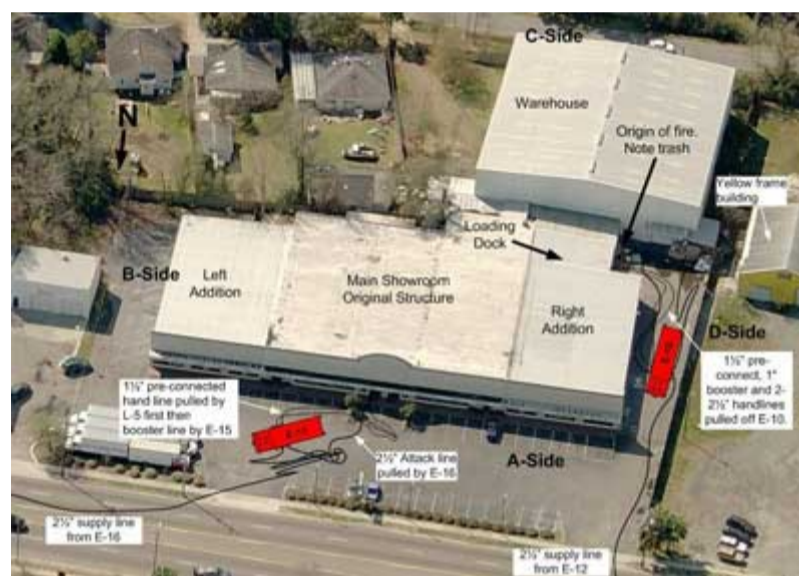
The E-16 engineer was instructed to lay a supply line for E-11 so he drove east on the highway toward where a hydrant had been previously located. This hydrant had been removed in 2004 because it had received damage from heavy truck traffic in the immediate area. He continued east to the next hydrant located approximately 1,200 feet away. Note: 1,850 feet of a single 2 ½" supply line was stretched from E-11 to the hydrant. The E-16 engineer reported hearing the radio traffic about the civilian worker being trapped in the rear of the building just as he was pulling up to the hydrant. ([see Diagram # 2](#))

Diagram 2. Location of Engine 10 and Engine 11, supply lines and hose lines pulled at different times during the incident. Note accumulation of trash at loading dock on the day photo was taken, 3 months prior to the incident. Note the absence of ventilation ductworks or other roof penetrations over the showroom, thus no path for smoke and hot gases to escape.

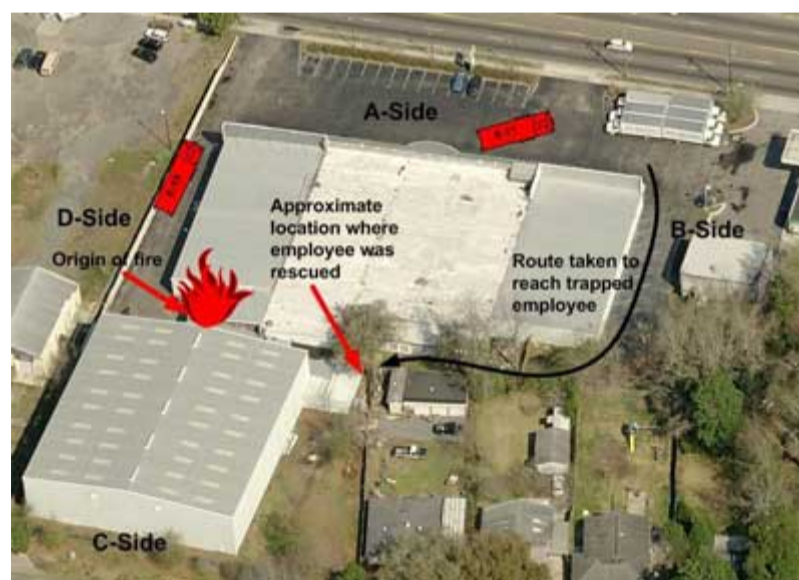
Diagram 3: Note location where mutual aid crew cut through exterior wall to extricate male employee trapped inside the warehouse. From aerial photo taken in 2007. (copyright Pictometry International – used with permission of Pictometry)

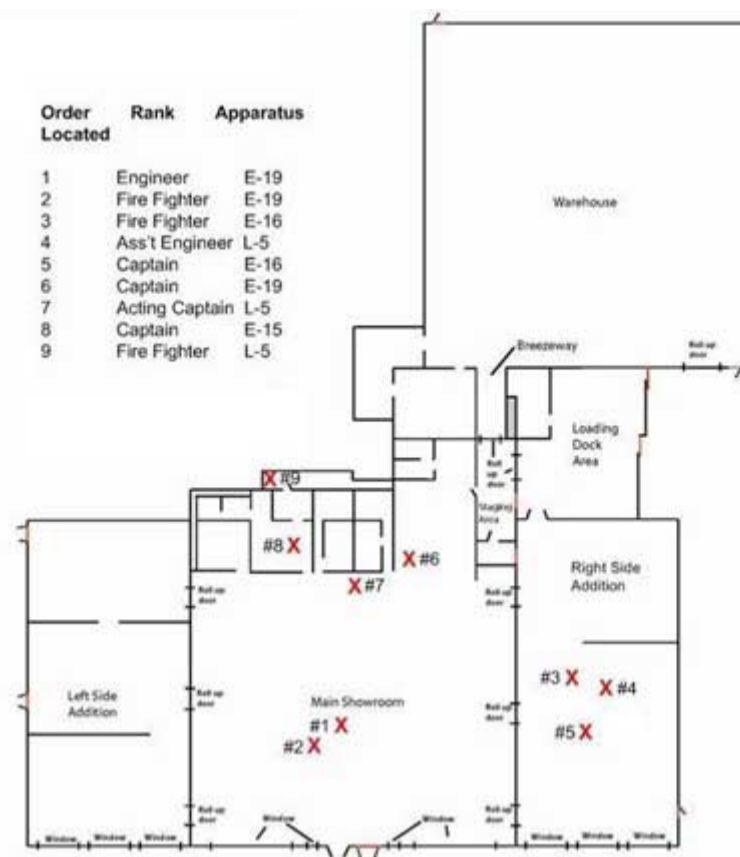
According to the county coroner's report, the cause of death for all nine victims was carbon monoxide toxicity, smoke inhalation and thermal injury due to fire. [Diagram 4](#) shows the approximate location where each of the nine victims was located inside the structure per the city.

Diagram 4. Approximate location of the 9 victims.

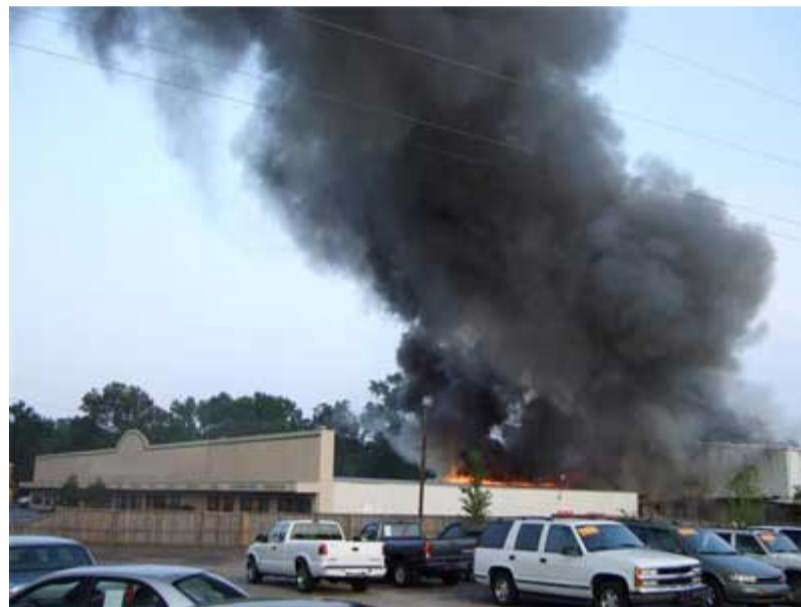
Photo A-1. Time is approximately 1923 hours. Fire is visible over showroom roof. Smoke is dark gray in color and becoming turbulent. The flames may not have been visible from front parking lot or close to the building on the D-side.
(Photo courtesy of Dan Folk.)

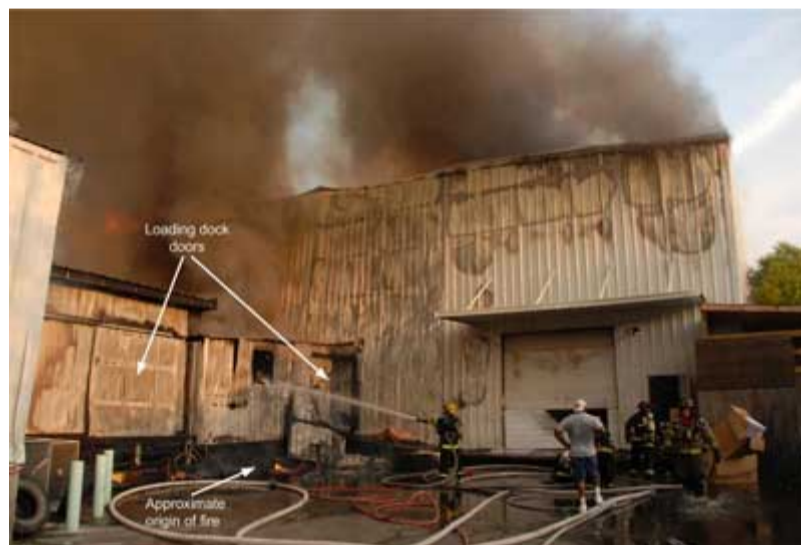
Photo A-2. Time is approximately 1936 hours. Loading dock area approximately 20 minutes after first crews arrived on scene. Note heat damage to metal siding on loading dock and warehouse.
(Photo courtesy of Police Department, Bill Murton, photographer.)

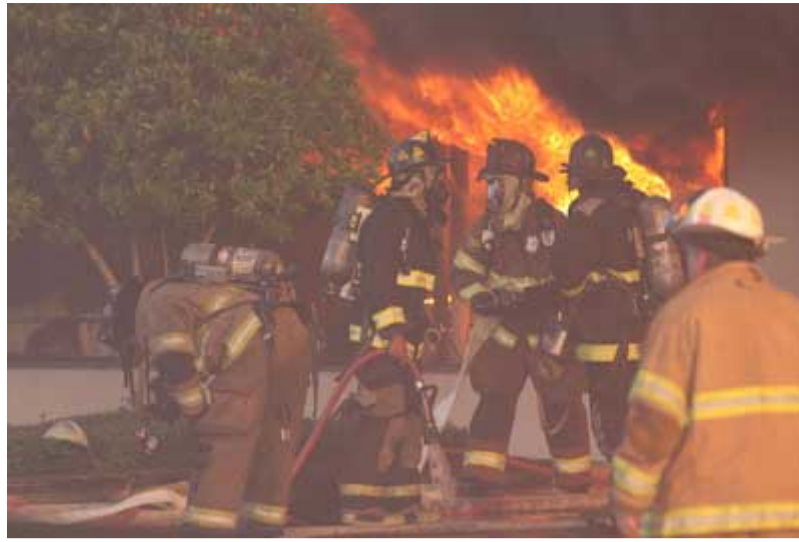
Photo A-3. Time approximately 1939 hours. Fire fighters near front entrance to showroom. Note lack of water pressure on the red booster line and the 2 ½" hand line. Also note lack of gloves and hood.

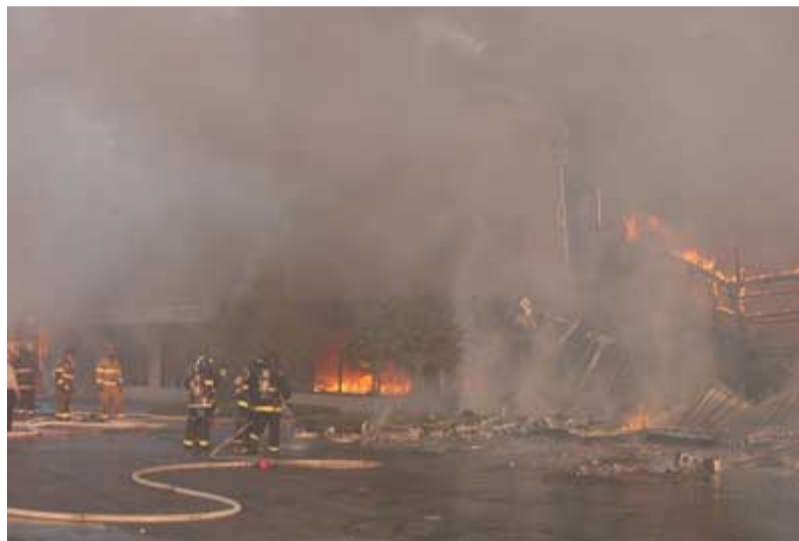
Photo A-4. Time approximately 1951 hours. Front façade beginning to collapse.
